# Manhole Inspection Summary

## Manhole # S29AA\_025MH

Insp Date: **11/26/07 12:28 PM**

**Location** Address: **1133 PENNSYLVANIA AVE**

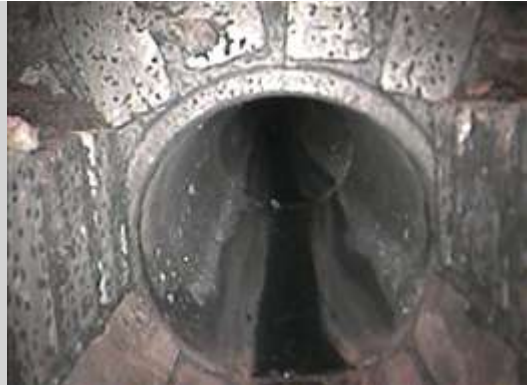
12 O'Clock Outflow

8 in. Circular Gravity Sewer  
Pipe Out @ 12 O'Clock

Pipe Height: (in.) Direct  
Pipe Material: **Clay** ☐ Pipe Lined  
Invert Depth: **12.64** (ft.) Flow Characteristics: **Slow**  
Deposits: ☒ None ☐ Mud ☐ Sludge ☐ Debris ☐ Grease  
Silt Depth: (in.) Deposits Extent:  
Infiltration: **None** Pipe Seal Cond: **Sound**

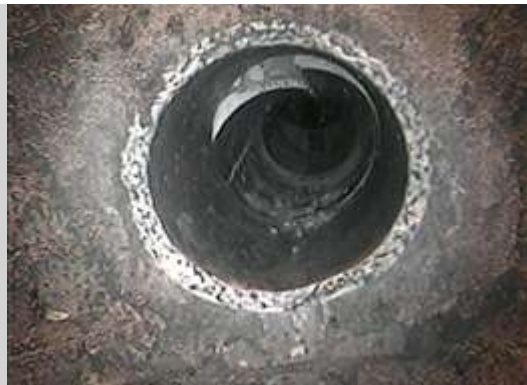
6 O'Clock Inflow

8 in. Circular Gravity Sewer  
Pipe In @ 6 O'Clock

Pipe Height: (in.) Direct  
Pipe Material: **Clay** ☐ Pipe Lined  
Invert Depth: **8.85** (ft.) Flow Characteristics: **Slow**  
Deposits: ☒ None ☐ Mud ☐ Sludge ☐ Debris ☐ Grease  
Silt Depth: (in.) Deposits Extent:  
Infiltration: **None** Pipe Seal Cond: **Sound**

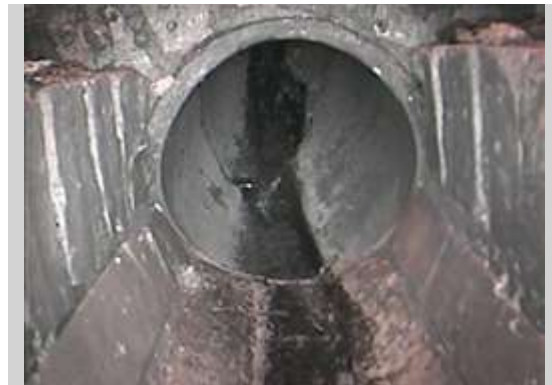
Drop In @ 6 O'Clock

Drop: **Outside Direct**  
Angled: Reading: (ft.)  
Inv Depth: **12.60** (ft.)  
Drop Condition: **Open**
